Inspection Date: 04-09-2016

About That Home LLC

# Full Report

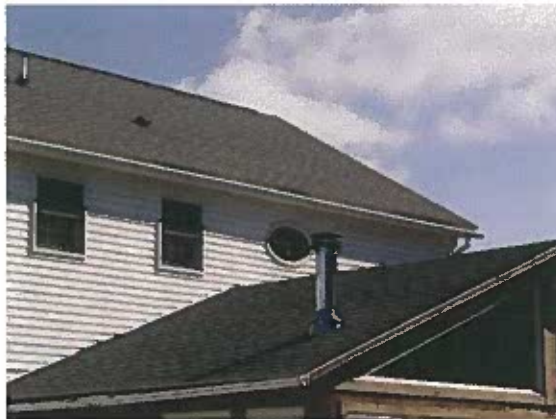
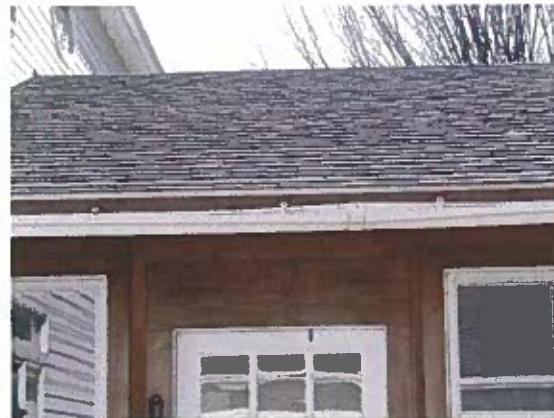
Siding trim is loose at valley between home and sunroom roof. A qualified contractor should evaluate and make repairs and/or replace trim as necessary to prevent water intrusion.

04/11/2016 Siding trim is loose at valley between home and sunroom roof. A qualified contractor should evaluate and make repairs and/or replace trim as necessary to prevent water intrusion.

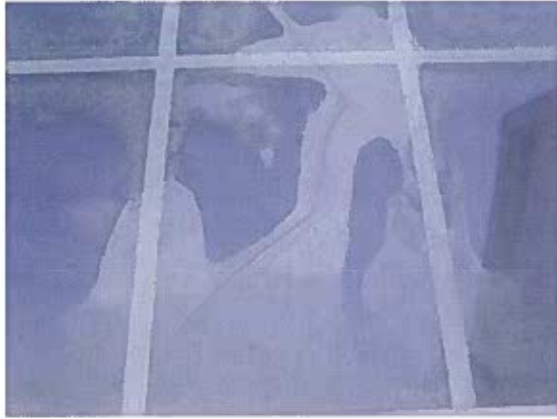
A window pane at front side of home was cracked and fogged. This condition presents a safety concern potential from broken glass and makes the window ineffective as an insulating surface. Recommend having a qualified contractor make repairs as necessary.

04/11/2016 A window pane at front side of home was cracked and fogged. This condition presents a safety concern potential from broken glass and makes the window ineffective as an insulating surface. Recommend having a qualified contractor make repairs as necessary.

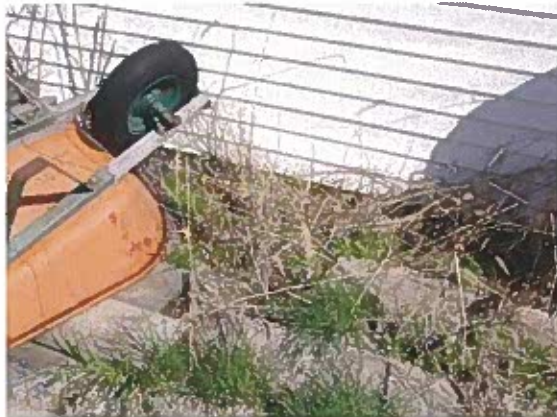
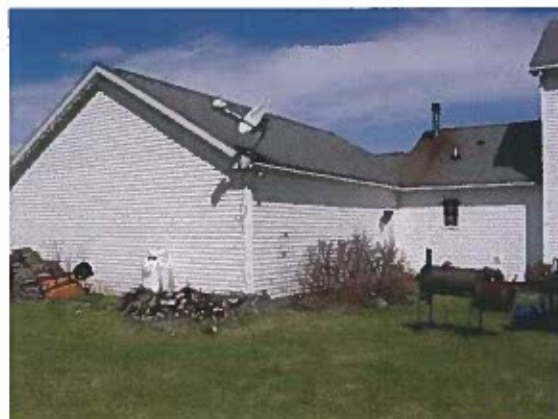
Soil is in contact with or less than 6" from siding and/or trim. Recommend grading soil so there's at least 6" of space between the siding and trim and the soil below.

04/12/2016 Soil is in contact with or less than 6" from siding and/or trim. Recommend grading soil so there's at least 6" of space between the siding and trim and the soil below.

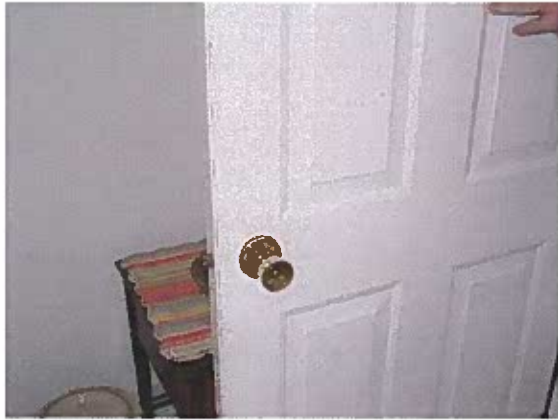
This door should auto close and latch. It was not latching at the time of the inspection. This condition can lead to exhaust fumes entering the home. Recommend adjusting spring hinge(s) to remedy this.

04/12/2016 This door should auto close and latch. It was not latching at the time of the inspection. This condition can lead to exhaust fumes entering the home. Recommend adjusting spring hinge(s) to remedy this.

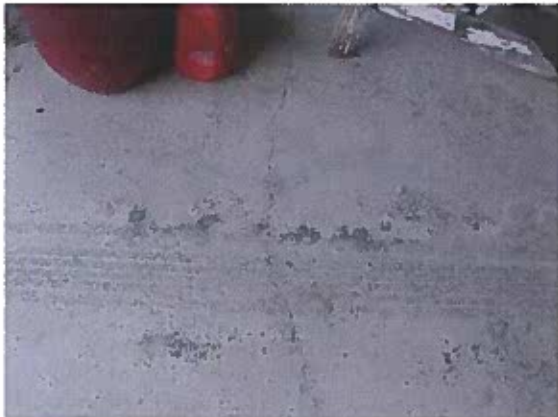
04/12/2016 A car parked in the garage at the time of the inspection obscured view of the floor in that area. Floor in visible area had cracks that are considered normal stress cracks.

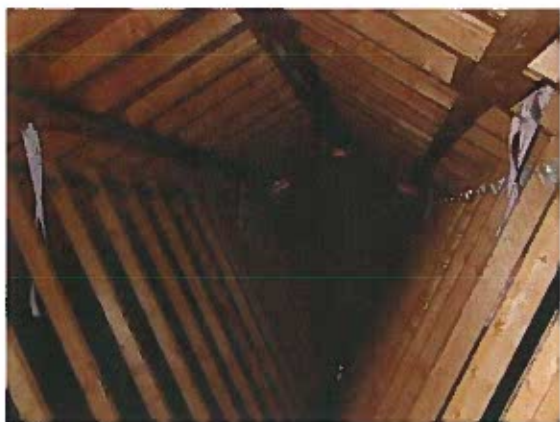
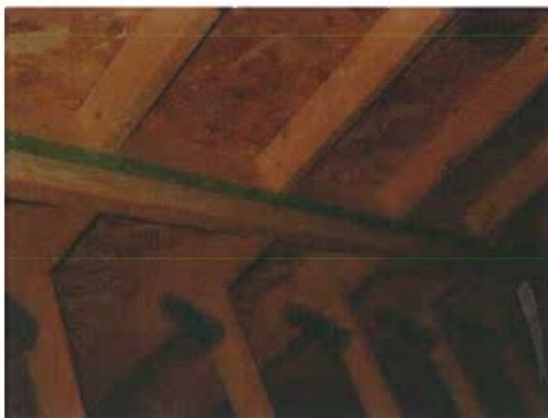
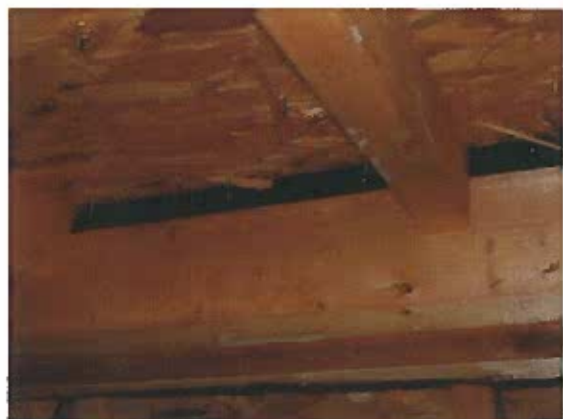
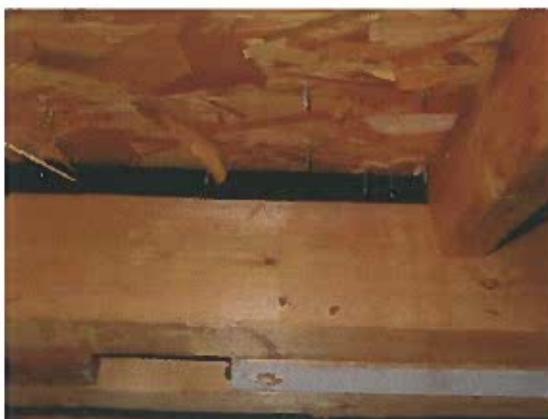
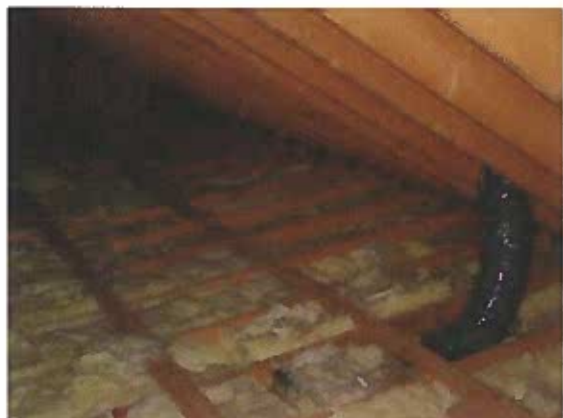
04/12/2016 Attic area was sufficiently vented and insulated. No evidence of moisture or water penetration. See photos

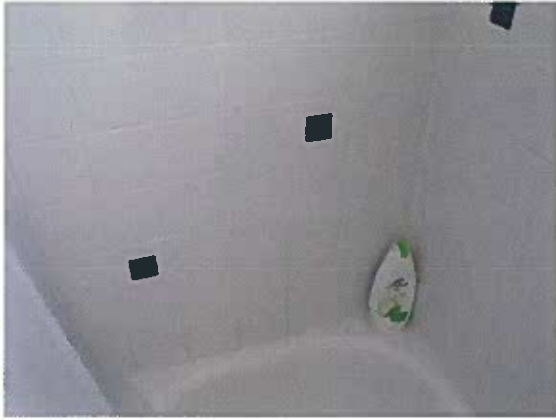
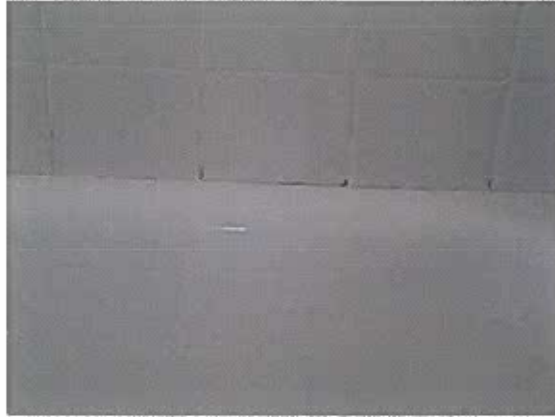
04/12/2016 Noted missing caulk in bathtub area. This will allow water penetration to effect sub flooring and may damage wood. Recommend a qualified contractor repair or replace as necessary.

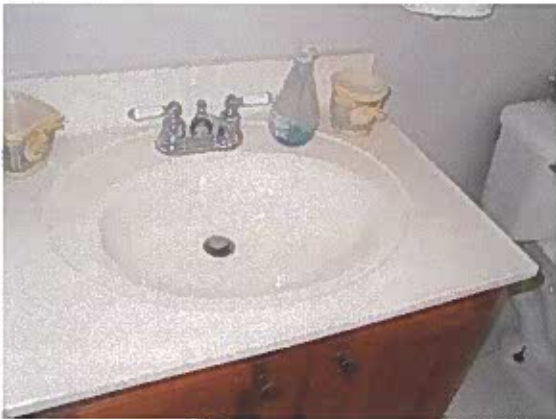
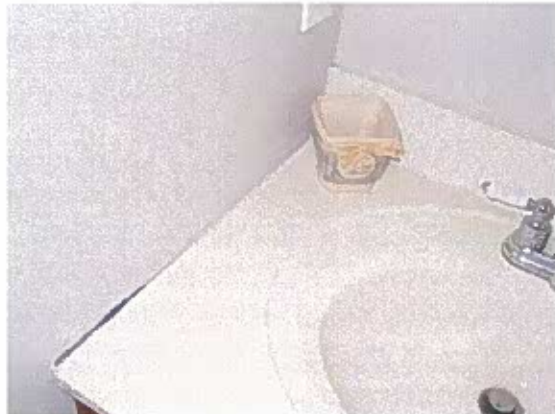
04/12/2016 No noted defects in bathroom.

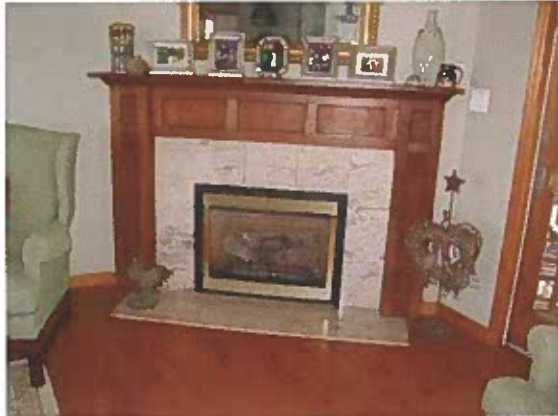
Recommend a level 2 inspection performed by a qualified chimney sweep. This inspection will determine the condition of the flue liner.

04/12/2016 Recommend a level 2 inspection performed by a qualified chimney sweep. This inspection will determine the condition of the flue liner.

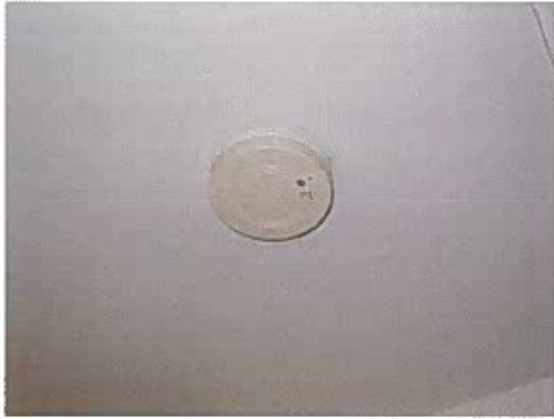
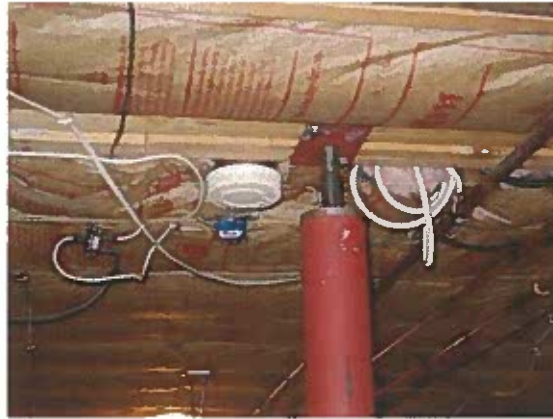
Did not see any Carbon monoxide detectors at the time of inspection. Recommend installing these on each floor.

Did not see any Carbon monoxide detectors at the time of inspection.  
Recommend installing these on each floor.

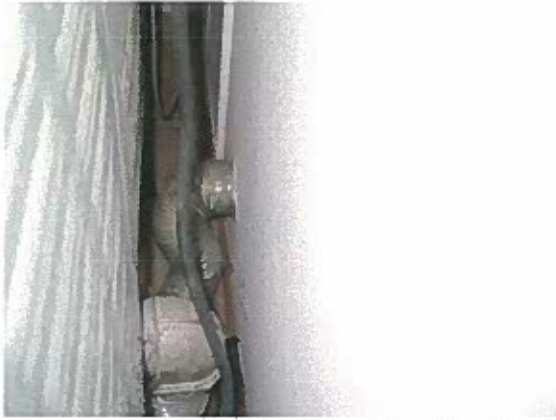
The clothes dryer is equipped with a vinyl or foil, accordion-type, flexible exhaust duct. The U.S. Consumer Product Safety Commission considers these types of ducts to be unsafe, and a fire hazard. These types of ducts can trap lint and are susceptible to kinks or crushing, which can greatly reduce the air flow. This duct should be replaced with a rigid or corrugated semi-rigid metal duct, and by a qualified contractor if necessary. Most clothes dryer manufacturers specify the use of a rigid or corrugated semi-rigid metal duct. See <http://www.cpsc.gov/CPSCPUB/PUBS/5022.html>.

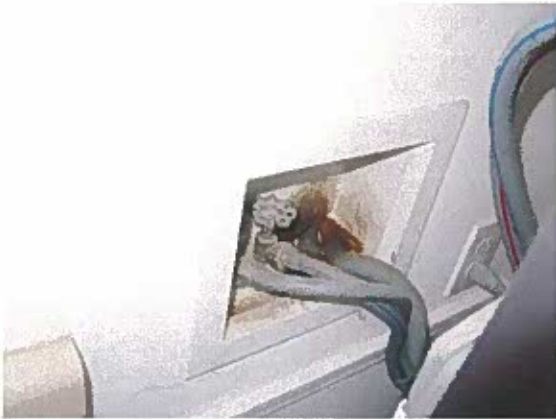
04/12/2016 Rubber hoses can be subject to bursting, which can cause significant water damage. If not present, recommend installation of burst proof metal braided hoses.

Rubber hoses can be subject to bursting, which can cause significant water damage. If not present, recommend installation of burst proof metal braided hoses.

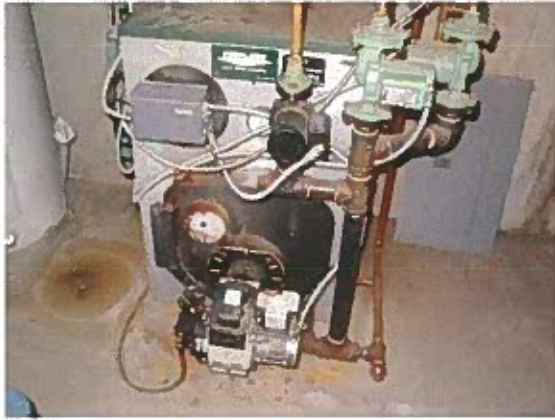
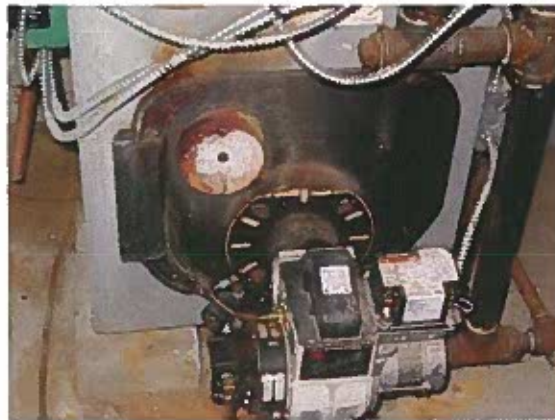
04/12/2016 System operated as designed on day of inspection.

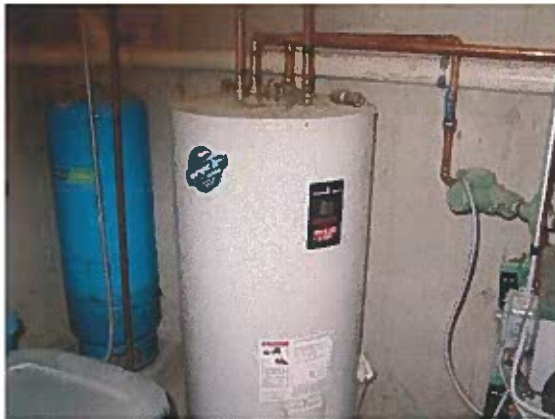
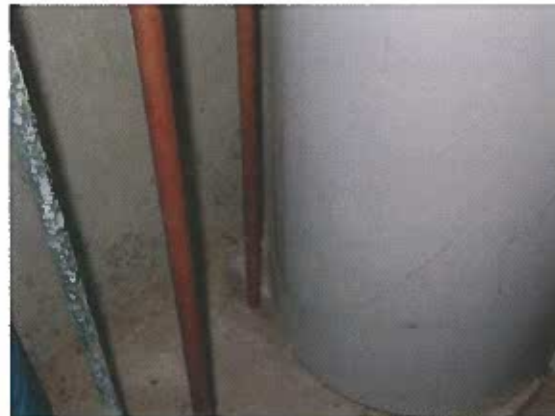
04/12/2016 Hot water heater operated as designed on the day of the inspection.

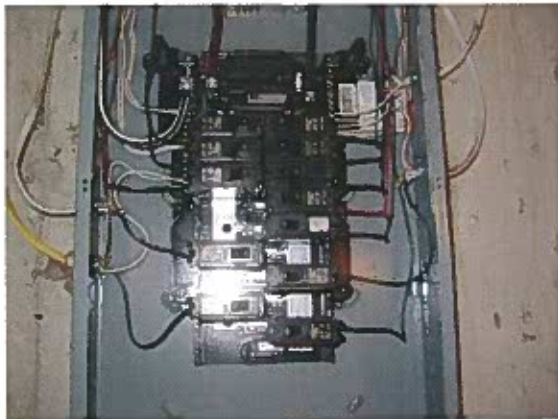
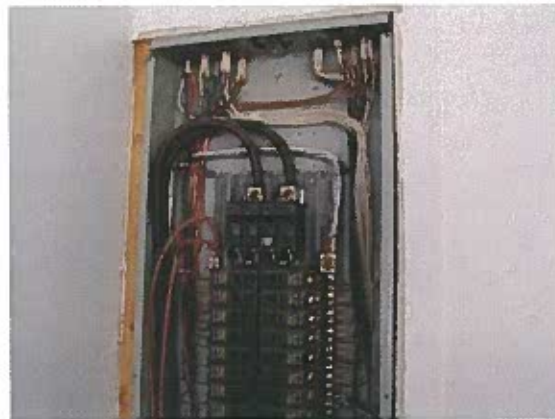
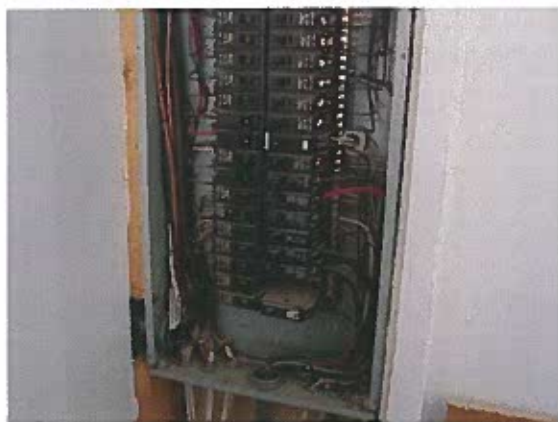
04/12/2016 There were no visible defects in panel at time of inspection. System worked as designed.

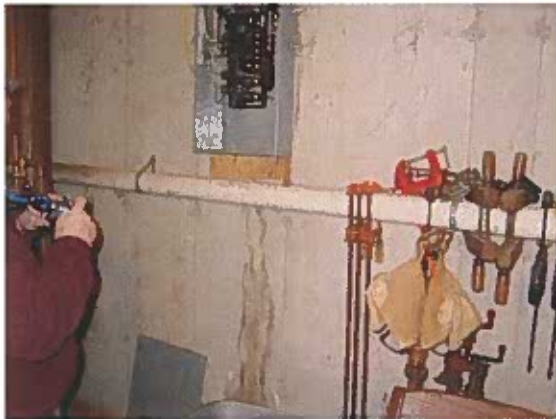
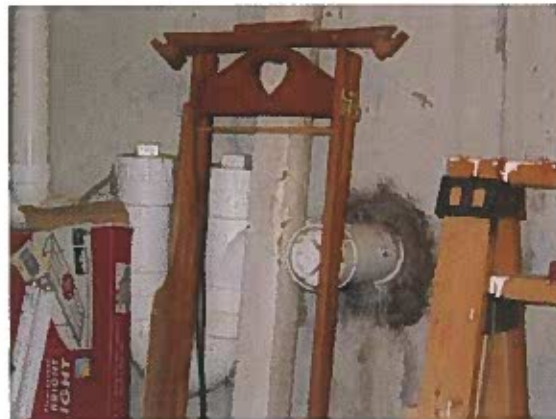
04/12/2016 There were no active leaks noted at time of inspection. Kitchen drain mentioned earlier is an exception.

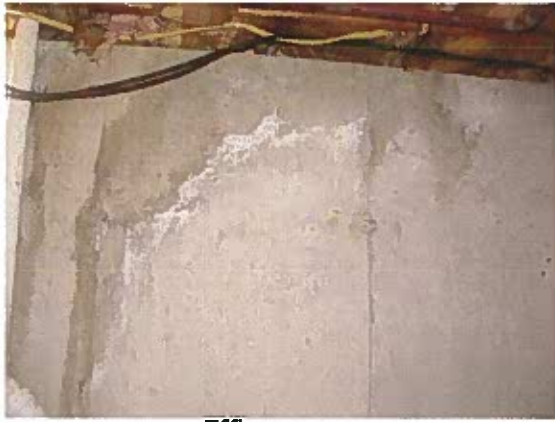
Some beginning signs of moisture on foundation walls. Recommend gutters be repaired and maintained on house to keep water away from foundation. Efflorescence noted at wall near rear garage door. There was also moisture evidence under the electric panel, which may be due to a wall crack or possibly a foundation crack below the main electrical entry point. Recommend filling the exterior foundation crack and calking the entry pipe.
